DOT/FAA/AR-95/81

Corrosion of Aluminum Alloys in the Presence of Fire-Retardant Aircraft Interior Materials

October 1995

Final Report

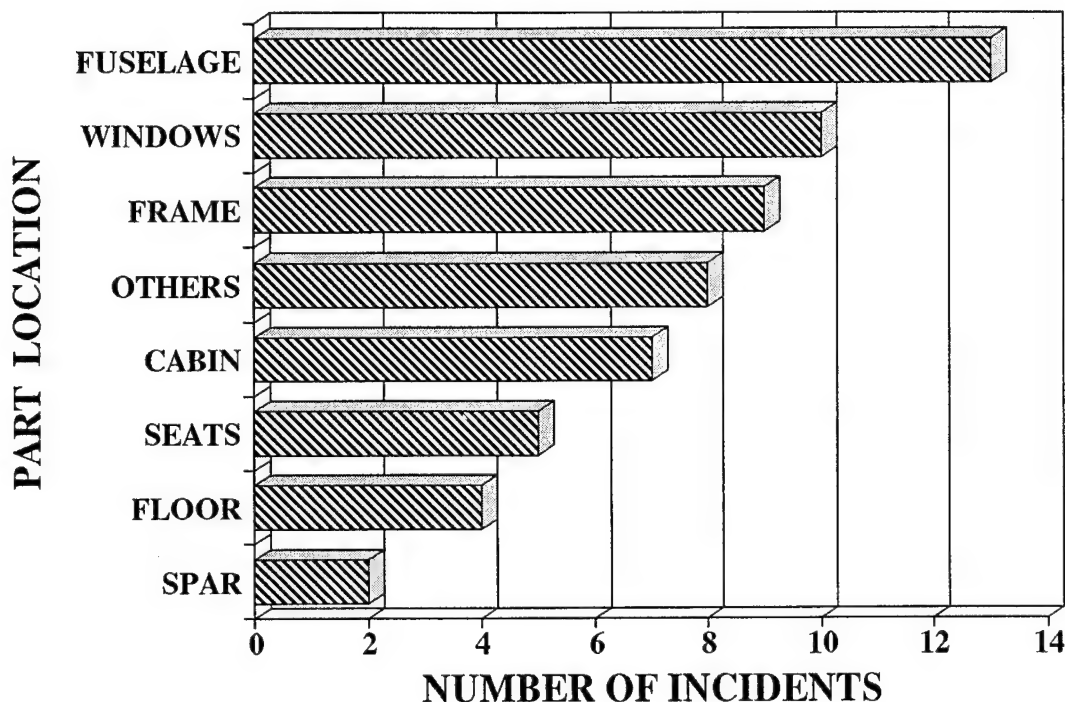
FIGURE 2. CORROSION INCIDENTS BY LOCATION

Figure 1 presents a histogrammic representation of various corrosion cases from SDR's with respect to the aircraft manufacturers. Figure 2 presents the locations at which corrosion was reported in SDR's. This graph illustrates that the most frequently observed corrosion was in the fuselage, with especially high occurrences near windows and frames.

Reports stated that most of the corrosion was due to the presence of moisture in the fire-retardant insulation. In many of these cases the presence of moisture was due to window leaks, saturation by galley fluids, deterioration of cabin window sealant, and leaking door seals. Following are a series of suggested practices based on review of the SDR's:

- Windows should be leak proof and there should be no deterioration of window sealants.
- Insulation should be contained in a plastic bag so that it does not rest directly against the aircraft skin or structure.
- Interior of the aircraft should be coated with primer.
- Regular visual inspections should be conducted of the insulation in areas that can retain water.
- Insulation should be removed and dried if moisture gets in. It should not come in contact with metallic parts [7,8].

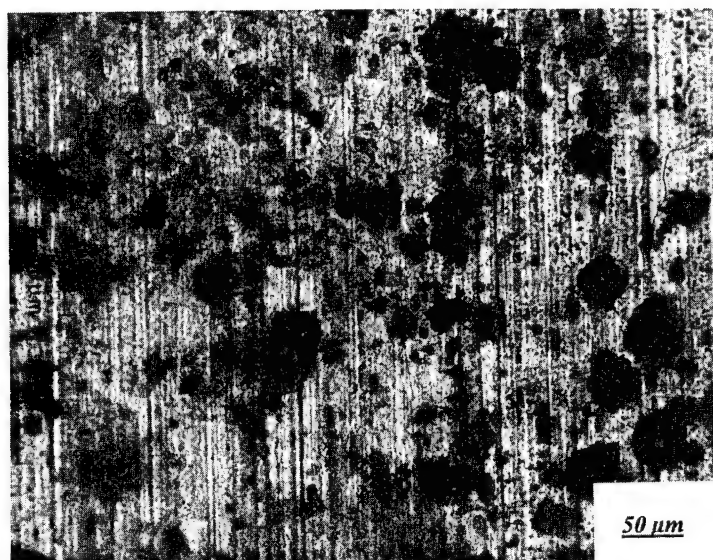
FIGURE 4. MICROGRAPH OF AL 7075-T6 WITH ULTRASUEDE, 100°F, 90% RH, 21 DAYS (SEVERE CORROSION, 100 POINTS)

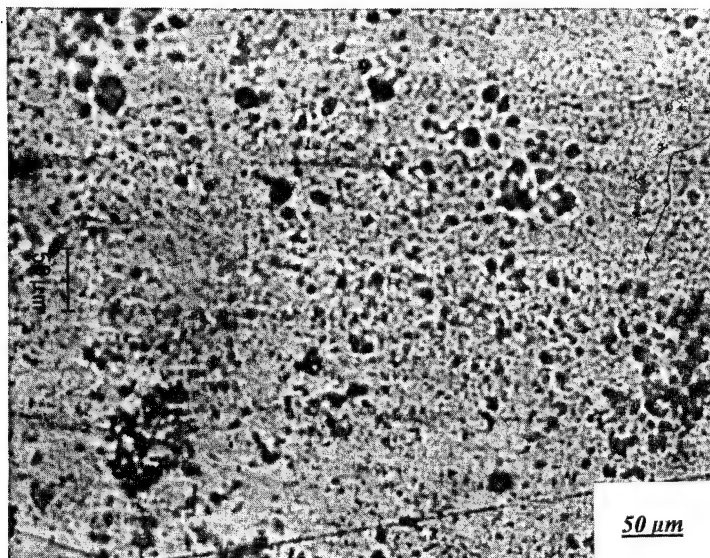
FIGURE 5. MICROGRAPH OF AL 2024-T3 WITH GLENLIVIT, 100°F, 90% RH, 14 DAYS
(MODERATE CORROSION, 50 POINTS)

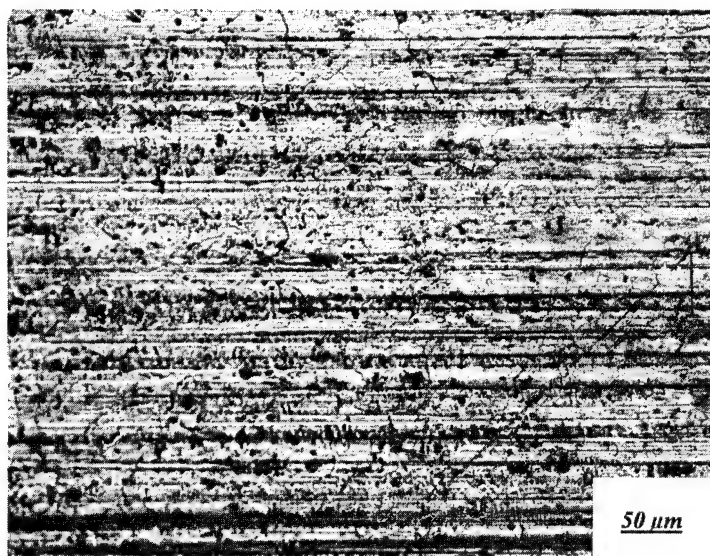
FIGURE 6. MICROGRAPH OF AL 7075-T6 WITH HIGHLAND WOOL, 70°F, 50% RH,
7 DAYS (MINIMAL CORROSION, 5 POINTS)

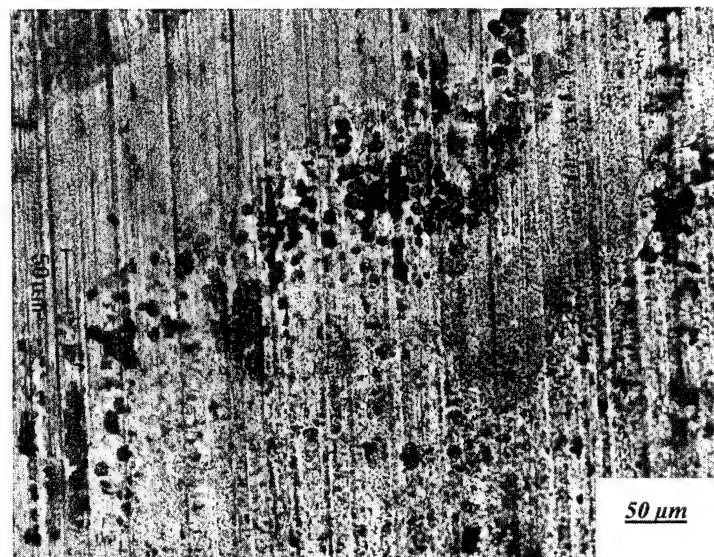
FIGURE 7. AL 2024-T3 WITH ULTRASUEDE, 100°F, 90% RH, 21 DAYS
(50 POINTS)

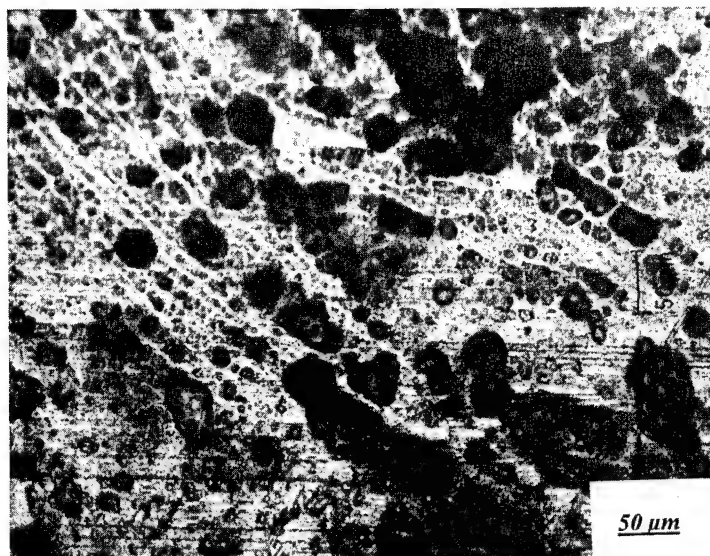
FIGURE 8. AL 2024-T3 WITH ULTRASUEDE, 130°F, 90% RH, 14 DAYS
(80 POINTS)

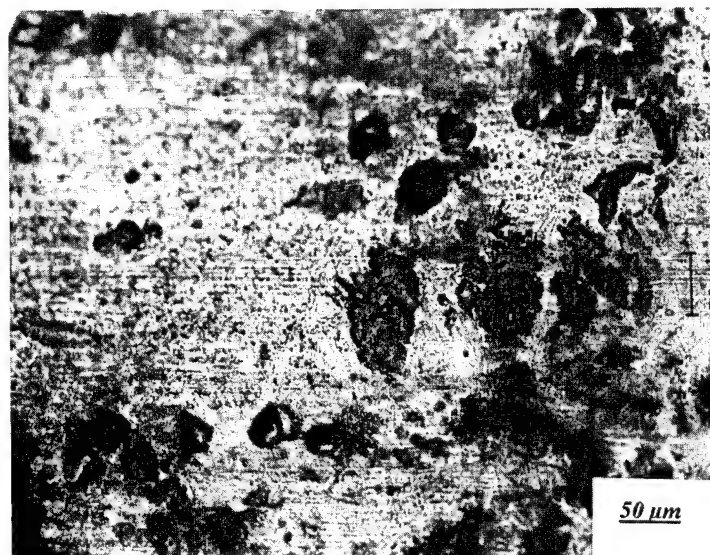
FIGURE 9. AL 7075-T6 WITH ULTRASUEDE, 70°F, 50% RH, 21 DAYS
(40 POINTS)

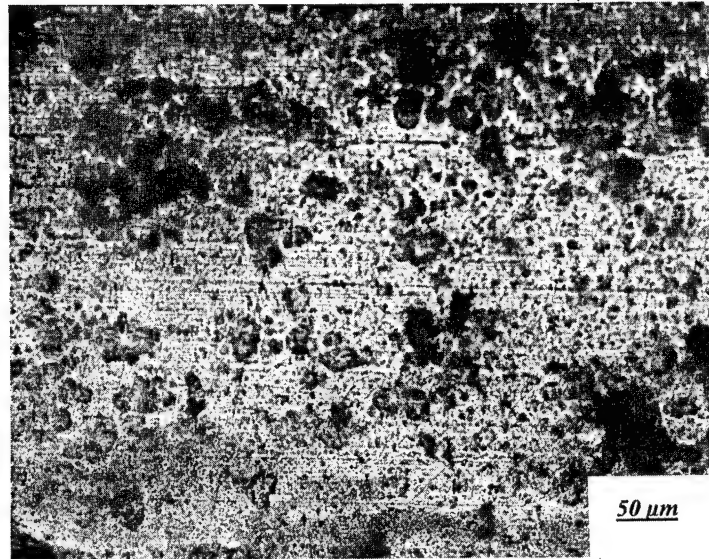
FIGURE 10. AL 7075-T6 ALCLAD WITH ULTRASUEDE, 130°F, 90% RH, 21 DAYS
(40 POINTS)

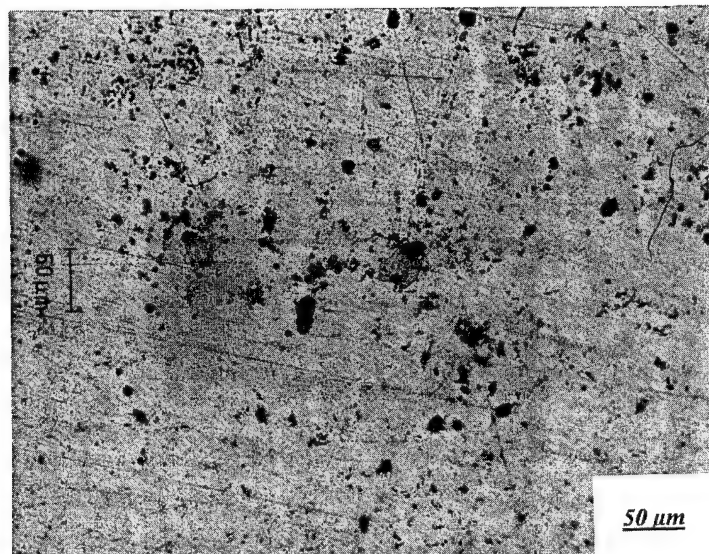
FIGURE 11. AL 2024-T3 WITH GLENLIVIT, 100°F, 90% RH, 21 DAYS
(65 POINTS)

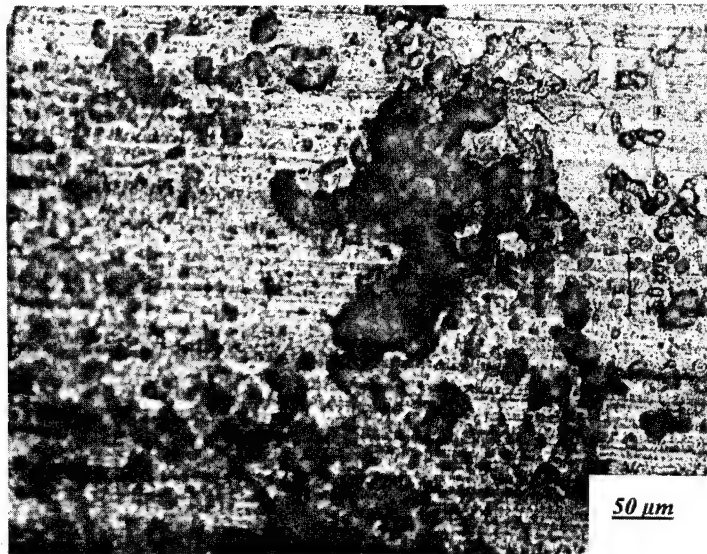
FIGURE 12. AL 2024-T3 ALCLAD WITH GLENLIVIT, 130°F, 50% RH, 14 DAYS
(80 POINTS)

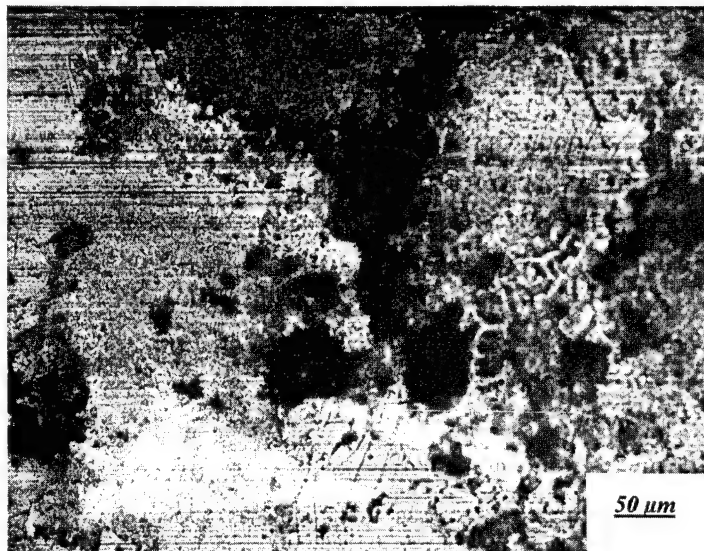
FIGURE 13. AL 7075-T6 ALCLAD WITH GLENLIVIT, 130°F, 50% RH, 21 DAYS
(55 POINTS)

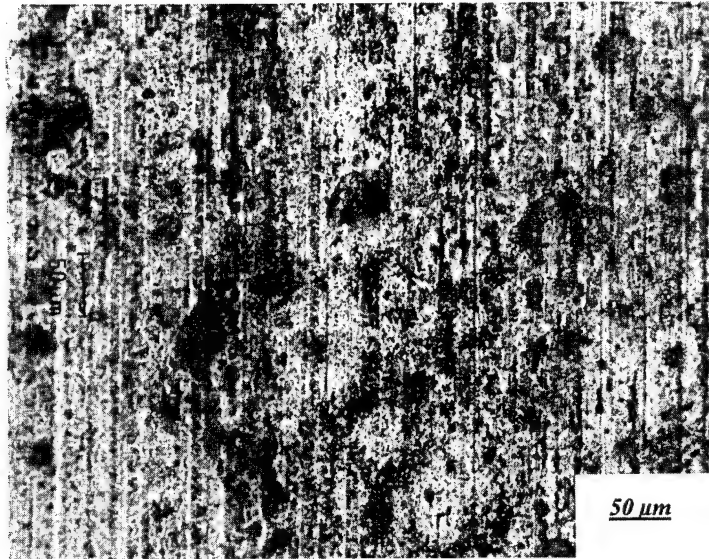
FIGURE 14. AL 2024-T3 WITH GLENLIVIT, 130°F, 90% RH, 21 DAYS
(85 POINTS)

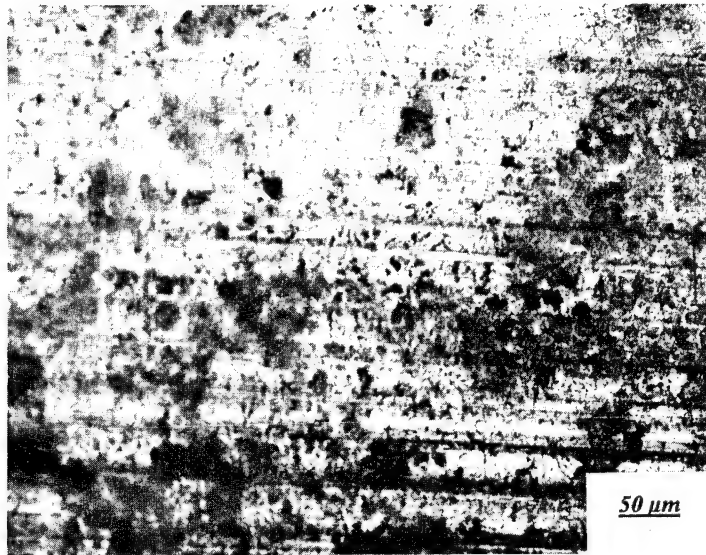
FIGURE 15. AL 2024-T3 WITH HIGHLAND WOOL, 70°F, 90% RH, 7 DAYS
(40 POINTS)

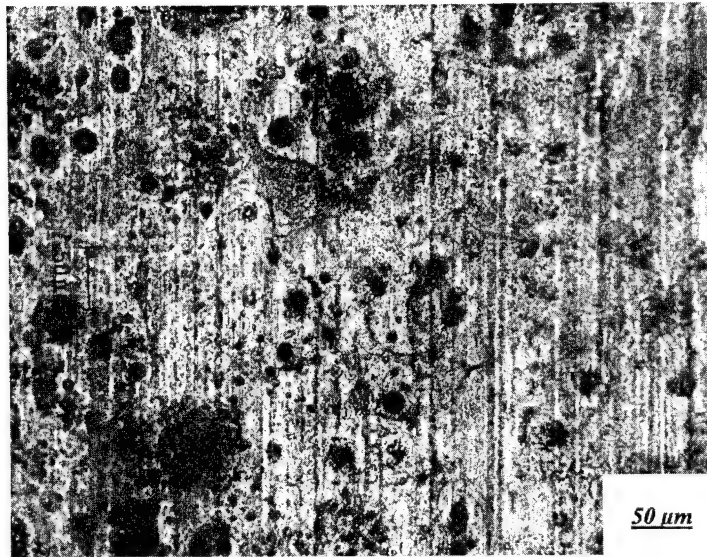
FIGURE 16. AL 7075-T6 WITH HIGHLAND WOOL, 130°F, 50% RH, 7 DAYS
(45 POINTS)
